# Technical Memorandum

Project Title: Stormwater IDDE Program

Subject: May 2020 Illicit Discharge Detection and Elimination Investigations

Date: August 5, 2020

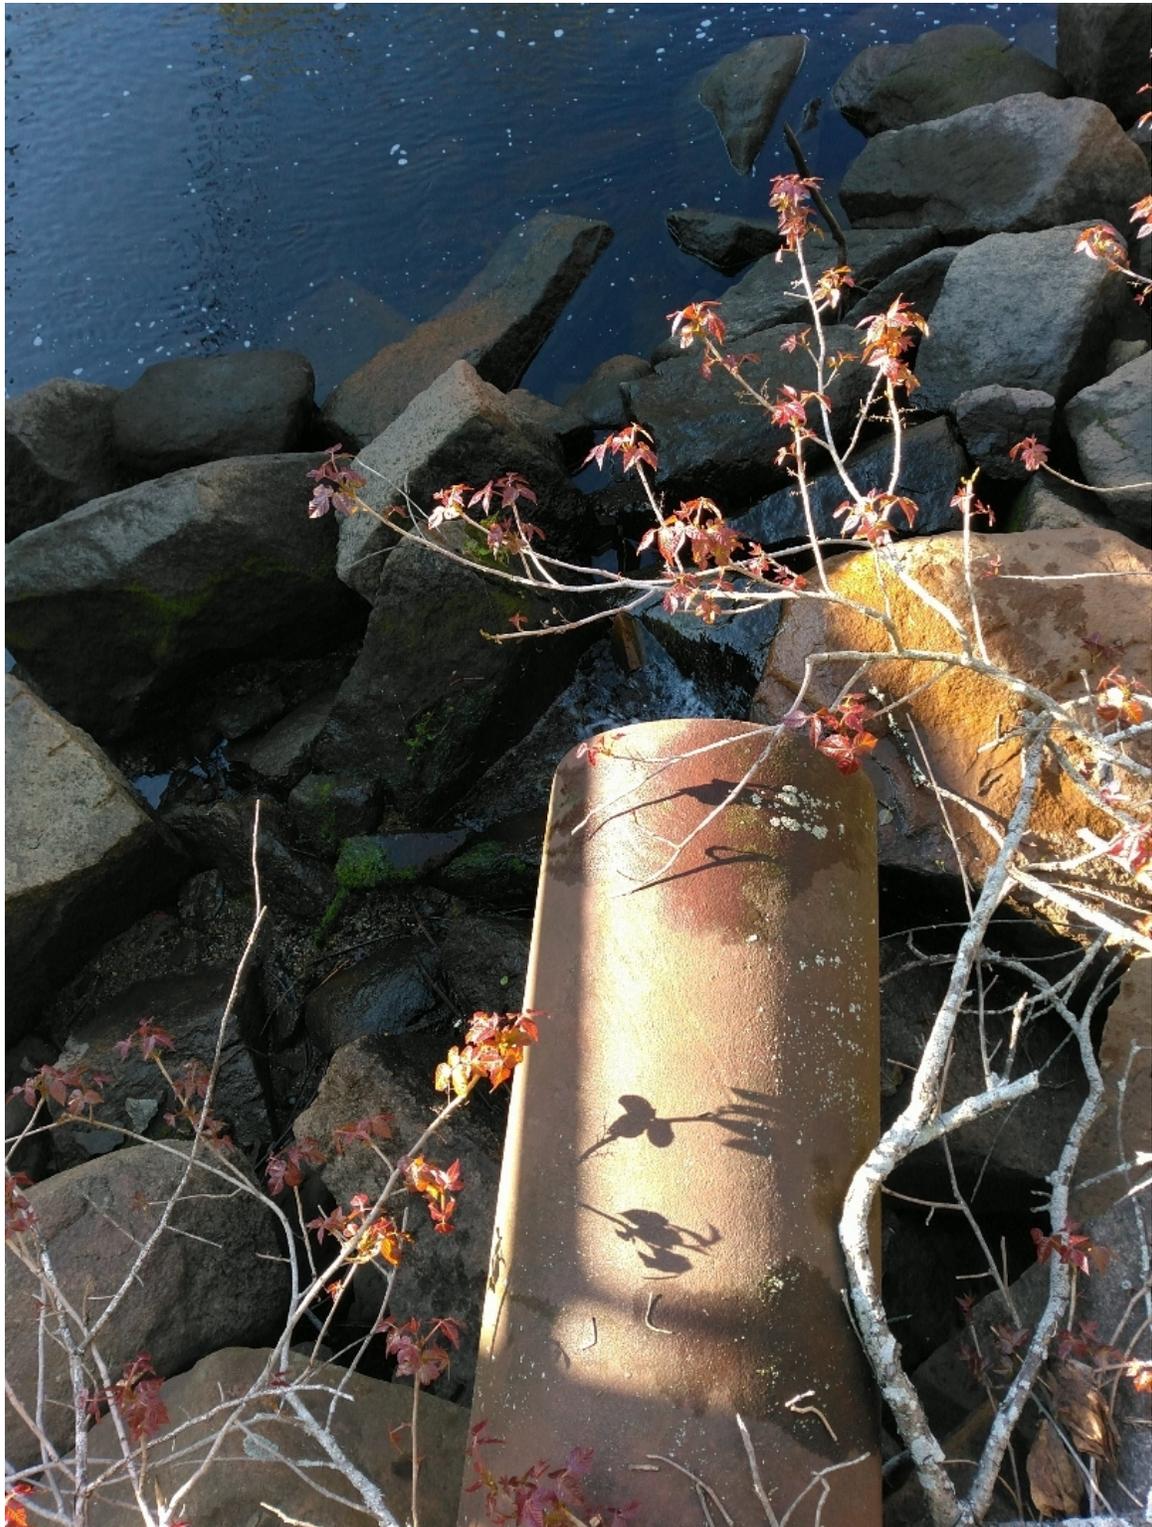
Figure 2. Photograph of MQR-005 Outfall

The results of the investigations at the outfall are shown in Table 2. Flows were observed at the outfall. There was no visual or olfactory evidence of sewage contamination and the bacteria concentration was 44 colonies/100 mL, well below the threshold. This outfall is not suspected having sewage contamination during the time of inspection.

Since the surfactant concentration of 0.25 mg/L was at the threshold level, upstream investigations were performed, but no sources of contamination were identified. This is to be expected since the bacteria data provides confirmation of no sewage contamination.

- Follow-up investigations at outfalls not suspected of sewage contamination (MQR-002, MQR-005, CDS-010) – Keep these as ‘high priority’ outfalls. Continue to perform dry weather sampling at these

outfalls at six-month intervals. If evidence of sewage contamination is identified, perform upstream flow tracking to isolate the source. If evidence of sewage contamination is not found on three consecutive investigations, change the status of the outfall to 'medium priority' and reduce the sampling frequency accordingly.

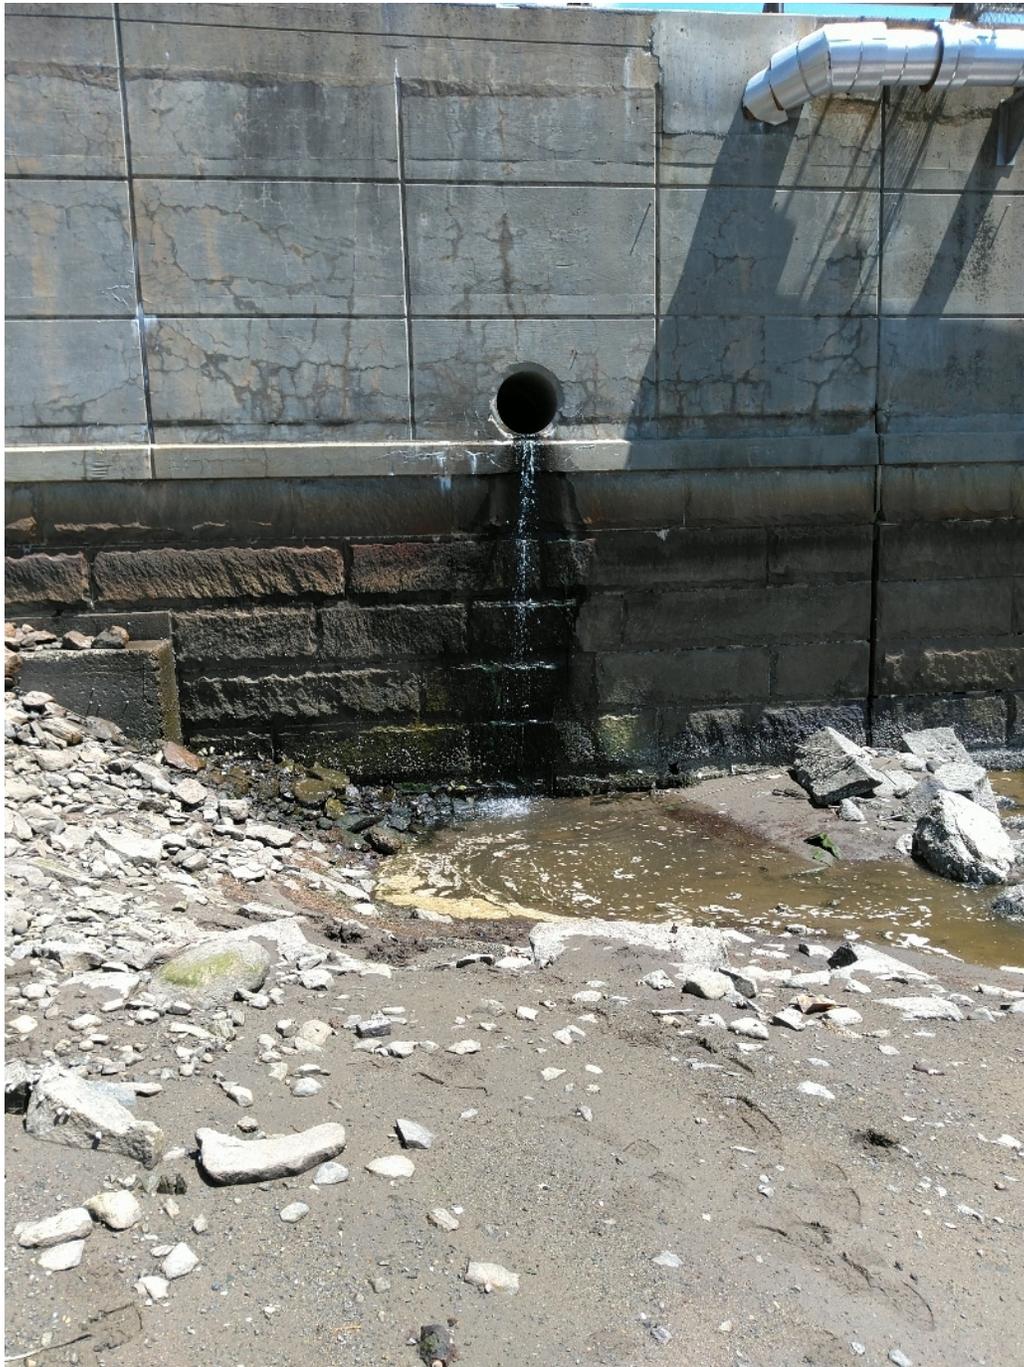
Figure 4. Photograph of MQR-002 Outfall

Flows were observed at the outfall. The results of the investigations at the outfall are shown in Table 2. There was no visual or olfactory evidence of sewage contamination and the bacteria concentration was 2 colonies/100 mL, well below the threshold. This outfall is not suspected having sewage contamination during the time of inspection.

Since the surfactant concentration of 0.25 mg/L was at the threshold level, upstream investigations were performed, but no sources of contamination were identified. This is to be expected since the bacteria data provides confirmation of no sewage contamination.

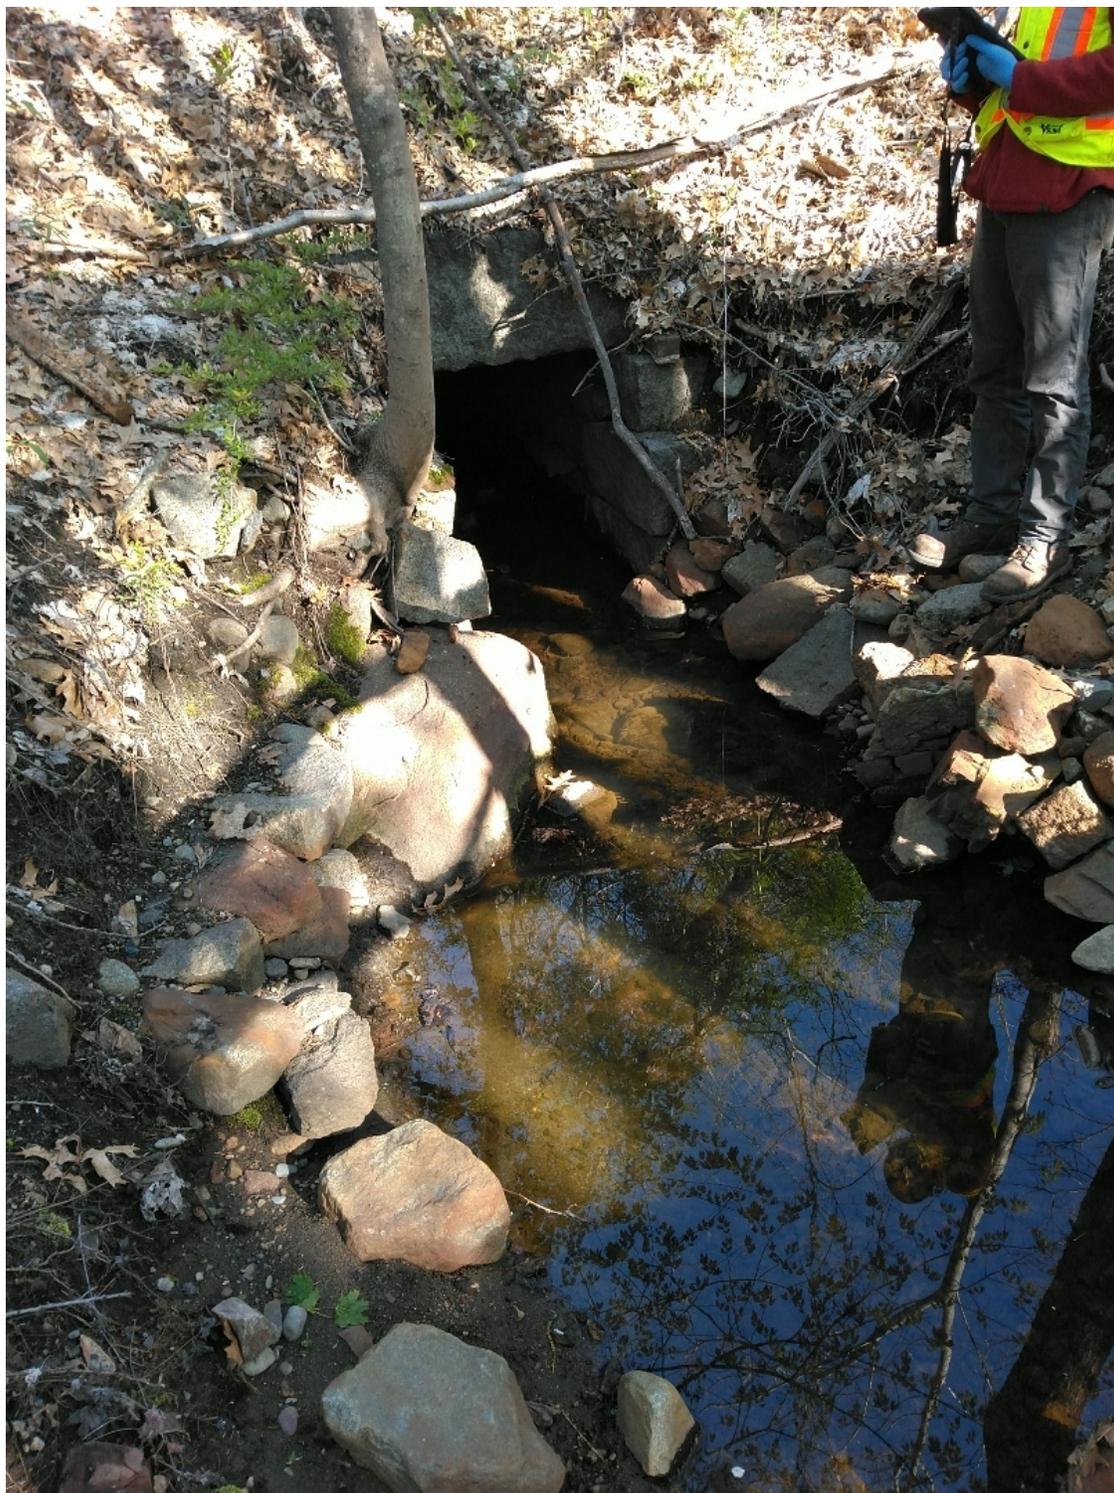
**Figure 6. Photograph of MQR-003 Outfall**

The results of the investigations at the outfall are shown in Table 2. At the outfall, the discharge waters were opaque and cloudy. There was a slight odor of raw sewage as well. These characteristics are possible indicators of sewage contamination. The bacteria concentration was 4,000 colonies/100 mL. This

concentration exceeds the threshold. The ammonia and surfactant concentrations also exceeded the thresholds, with an ammonia concentration of 0.6 mg/L being well above the threshold of 0.25 mg/L. These results indicate that MQR-003 may have illicit contamination.

Source tracking was performed upstream of MQR-003. During previous inspections (see Technical Memorandum 1, Brown and Caldwell, September 24, 2019), this outfall was suspected of having sewage contamination from a privately-owned surcharging sanitary manhole on Crescent Avenue, just upstream from the outfall. The Town had previously contacted the property owner to resolve the contamination. Those efforts appear to be successful as the inspection found no signs of sewage contamination from the sanitary manhole to the storm drain catch basin.

Source tracking found stormwater flow in the manhole in the intersection of Hancock Street and Frederick Road. In addition to the field test kit measurements, bacteria samples were collected at this manhole. A sample was collected from the pipe inlet to the north (storm drain Hancock Street) and from the west (Frederick Road). The Hancock Street pipe E. Coli concentration was 3.0 colonies/100 mL, and the Frederick Road pipe E. Coli concentration was 23 colonies/100 mL. Both of these concentrations are well below the concentration of 4,000 colonies/100 mL measured at the outfall. This indicates that the illicit source is located somewhere between the manhole at Hancock Street/Frederick Road and the stormwater outfall.

- MQR-003 - Perform CCTV inspections of the storm drains between the outfall and the intersection of Frederick Road and Hancock Street to identify connections to the storm drain and potential sources of contamination. If the CCTV inspections do not identify a likely illicit source, consider other investigations techniques such as dye testing of building connections. Once the illicit source is identified, take actions to remove it from the stormwater system. After the illicit connection has been removed, perform dry weather screen and sampling to confirm removal of the source.

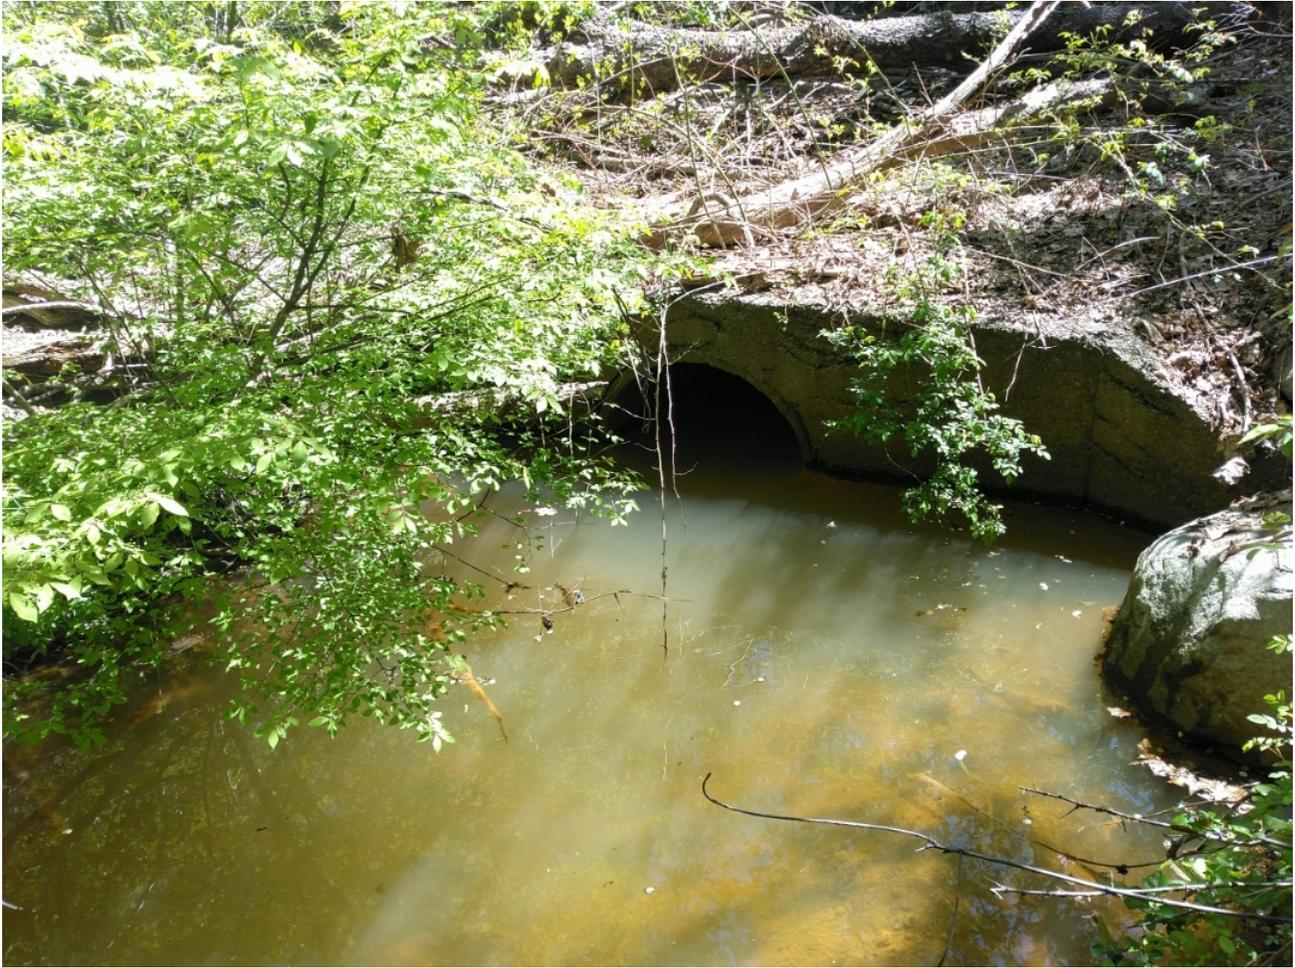
Figure 8. Photograph of CDS-010 Outfall

The fourth and final outfall inspected was CDS-010. It is located behind the house number at 32 Linda Road. The outfall is accessed via a right-of-way adjacent to the house at 30 Alida Road. The outfall is partially submerged and has significant sediment deposits in the scour pool. The outfall discharges to a low-lying wetland area behind the residences. This outfall is only visible from the heavily wooded area behind Linda Road and Alida Road. Figure 7 provides a map of the outfall's tributary area. Figure 8 provides a photograph of the outfall at the time of inspection.

Since CDS-010 was submerged, the water quality sampling was performed at an upstream manhole. The results of the investigations are shown in Table 2. There was no visual or olfactory evidence of sewage contamination. The bacteria concentration was 8.6 colonies/100 mL, below the threshold. Field test kits were not performed at this outfall because discoloration of the water made it difficult to interpret the field test kit results. CDS-010 is not suspected of having sewage contamination at the time the inspection was performed.

Even though the field test kits could not be performed at the manhole upstream of the outfall, upstream source tracking was initiated based on past evidence of sewage contamination at this outfall. Fortunately, the team was able to perform the field test kits at the upstream manholes which were unimpacted by the discoloration issues near the outfall. No conclusive evidence of sewage contamination was observed during the upstream source tracking which is consistent with the low bacteria concentration measured upstream of the outfall.
