# BRAINTREE ELECTRIC LIGHT DEPARTMENT

Pre-Development Feasibility Study  
Appendix

# APPENDIX APRIL 2014

PREPARED FOR THE TOWN OF BRAINTREE  
BRAINTREE ELECTRIC LIGHT DEPARTMENT  
44 ALLEN STREET

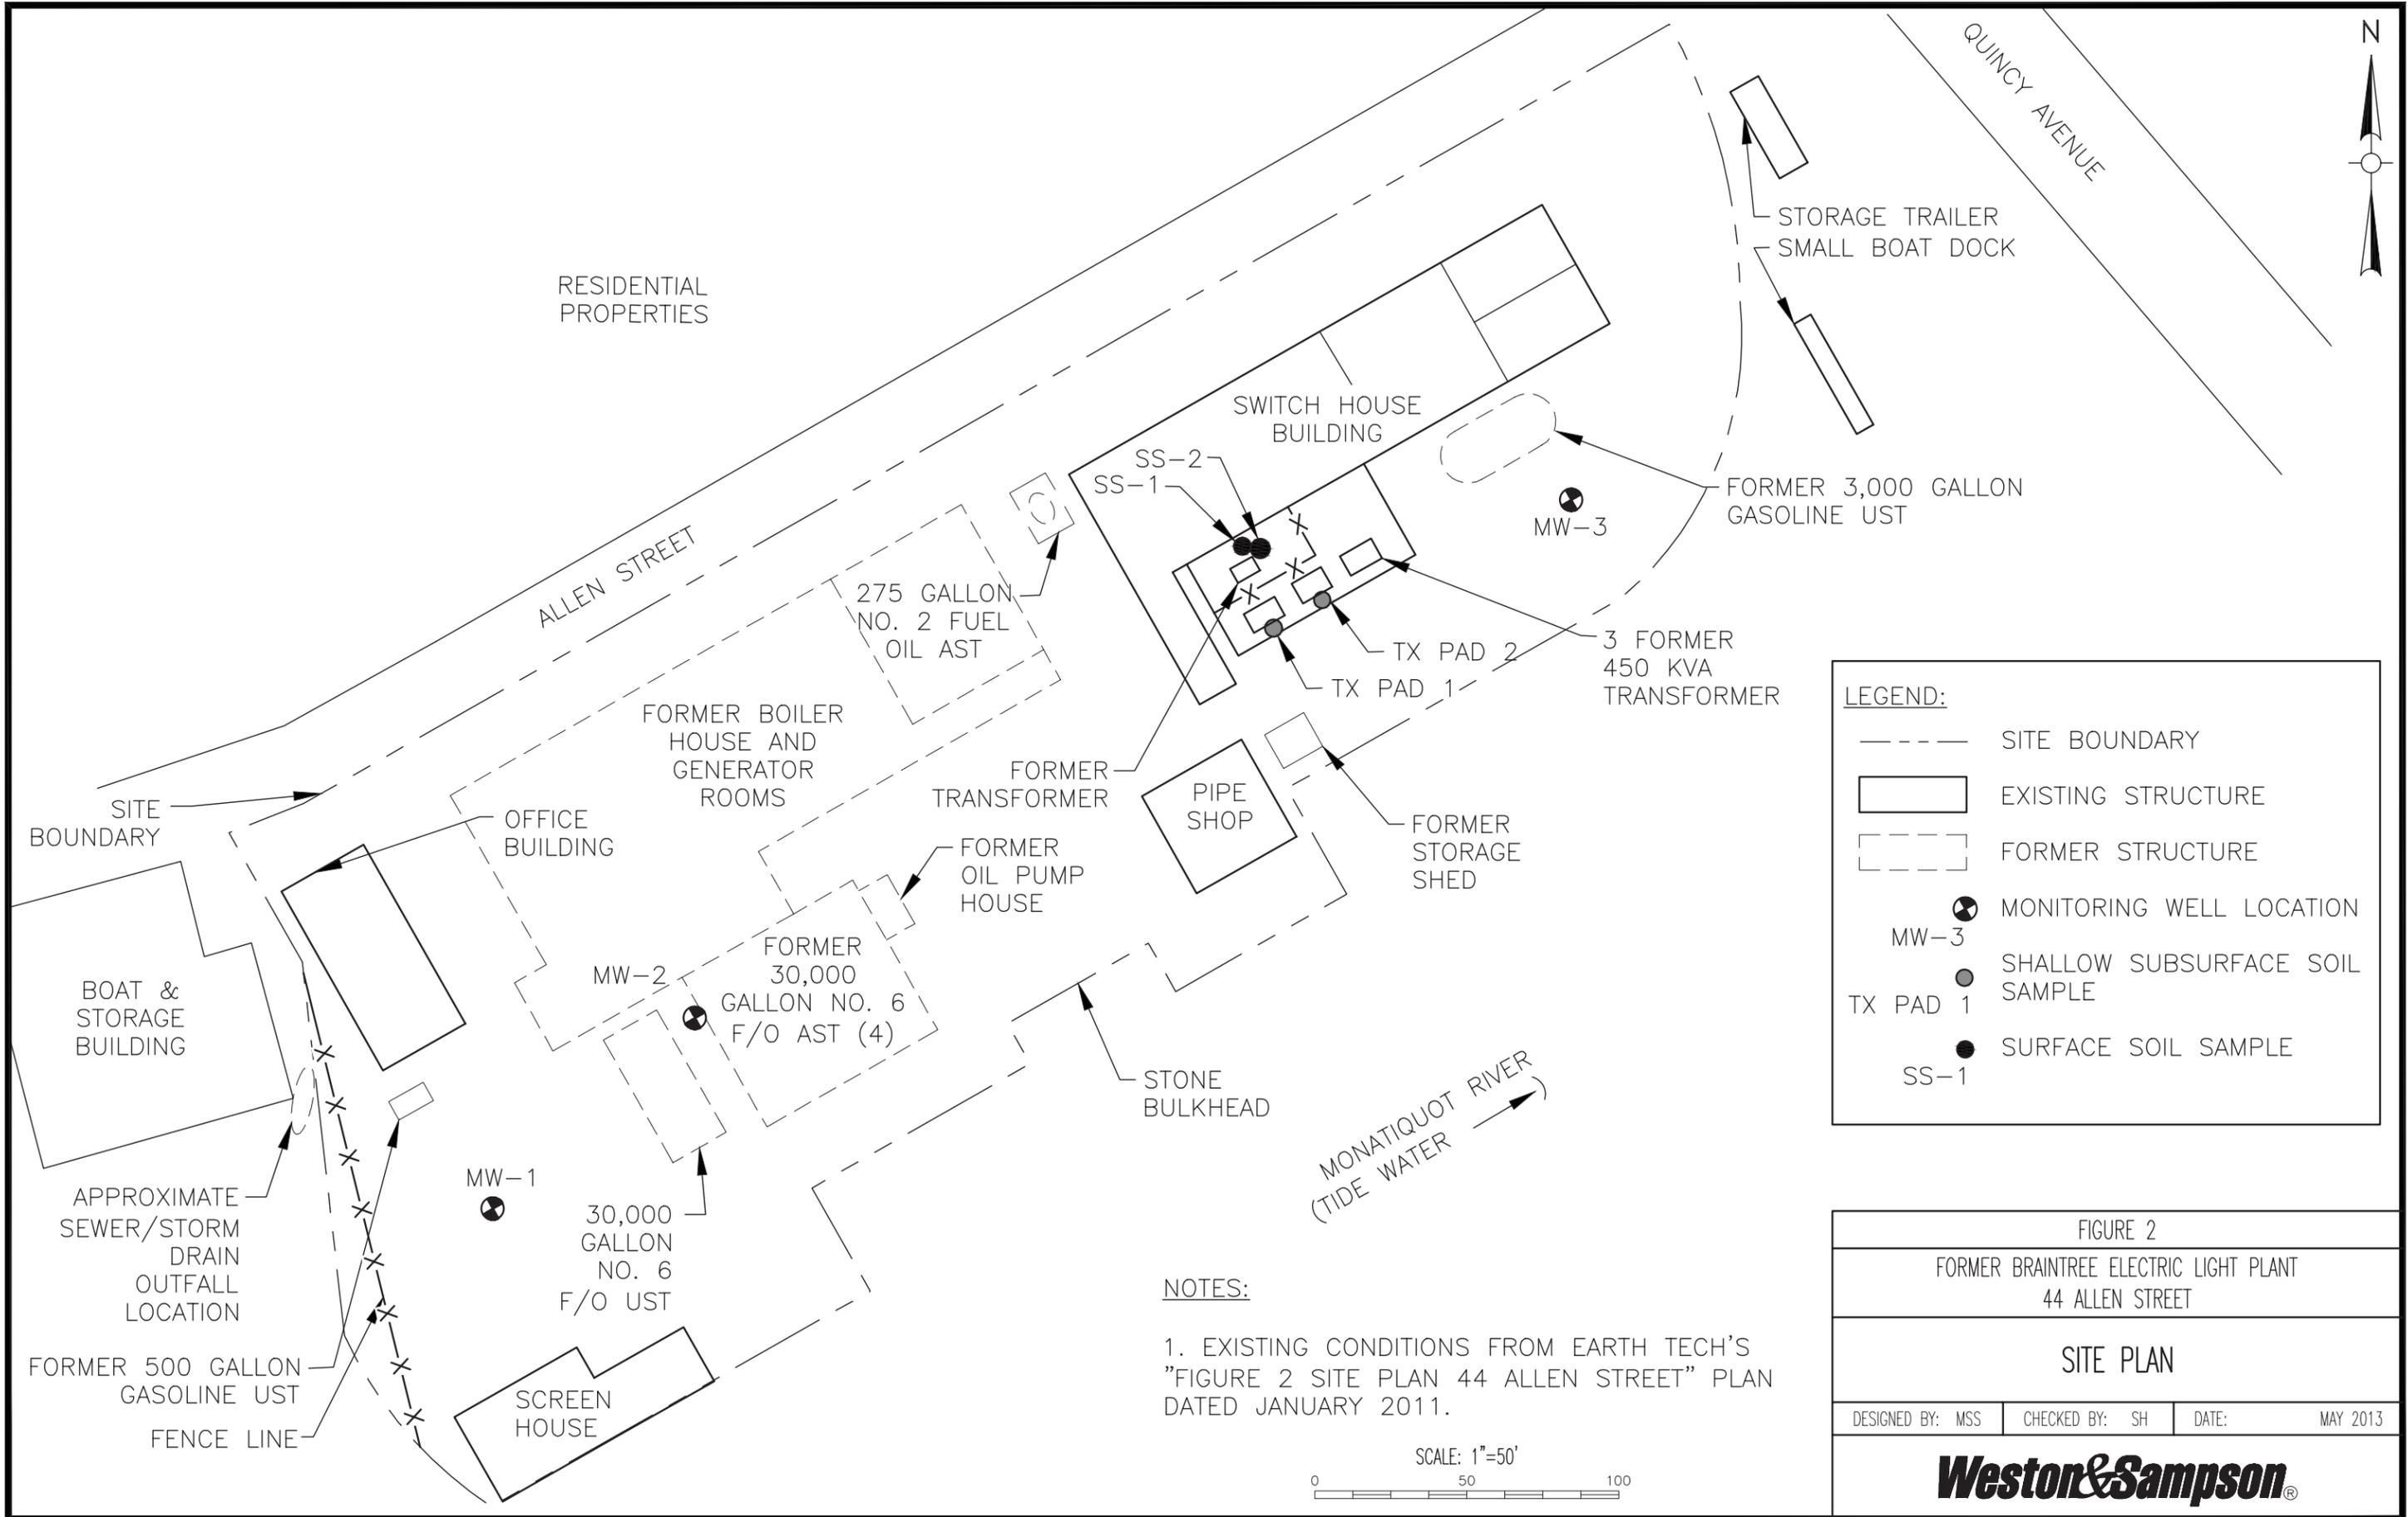
Z:\MA-Foxboro-Projects\SH ESS Projects\Braintree Electric- Allen Street\CADD\Figure2.dwg

1. EXISTING CONDITIONS FROM EARTH TECH'S "FIGURE 2 SITE PLAN 44 ALLEN STREET" PLAN DATED JANUARY 2011.

Weston & Sampson, on behalf of Gamble Associates, performed a Phase I Environmental Site Assessment (ESA) of the former Braintree Electric Light Department (BELD) property located at 44 Allen Street in Braintree, Massachusetts (the Site). The Phase I ESA was performed to evaluate environmental conditions as part of a Pre-Development Feasibility Study of the Site on behalf of the Town of Braintree. Please see Figure 1 and 2 for a depiction of the Site and surrounding properties.

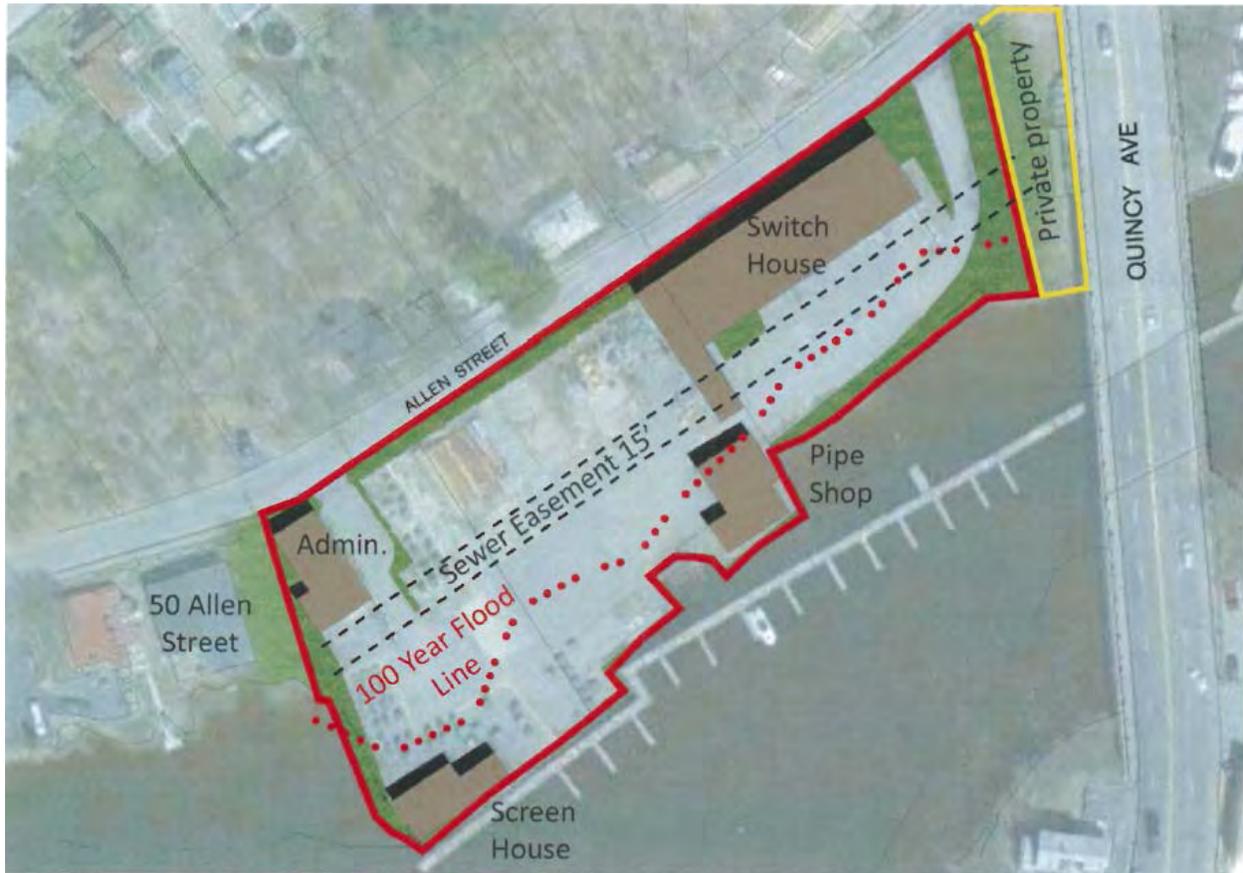
**Figure 1**  
**BELD Site Plan**

The site is currently owned by the Town of Braintree. It was transferred from BELD to the Town in 2011. The site is approximately 1.6 acres, and roughly rectangular in shape. Historically used for industrial purposes, it is no longer used for industry. There are four existing buildings on site that have been vacant since the Braintree Electric Department vacated the site in 1993 when a new facility was constructed nearby. **Figure 1** shows a site plan of the BELD site.
