# Technical Memorandum

Project Title: Stormwater IDDE Program

Subject: May 2020 Illicit Discharge Detection and Elimination Investigations

Date: August 5, 2020

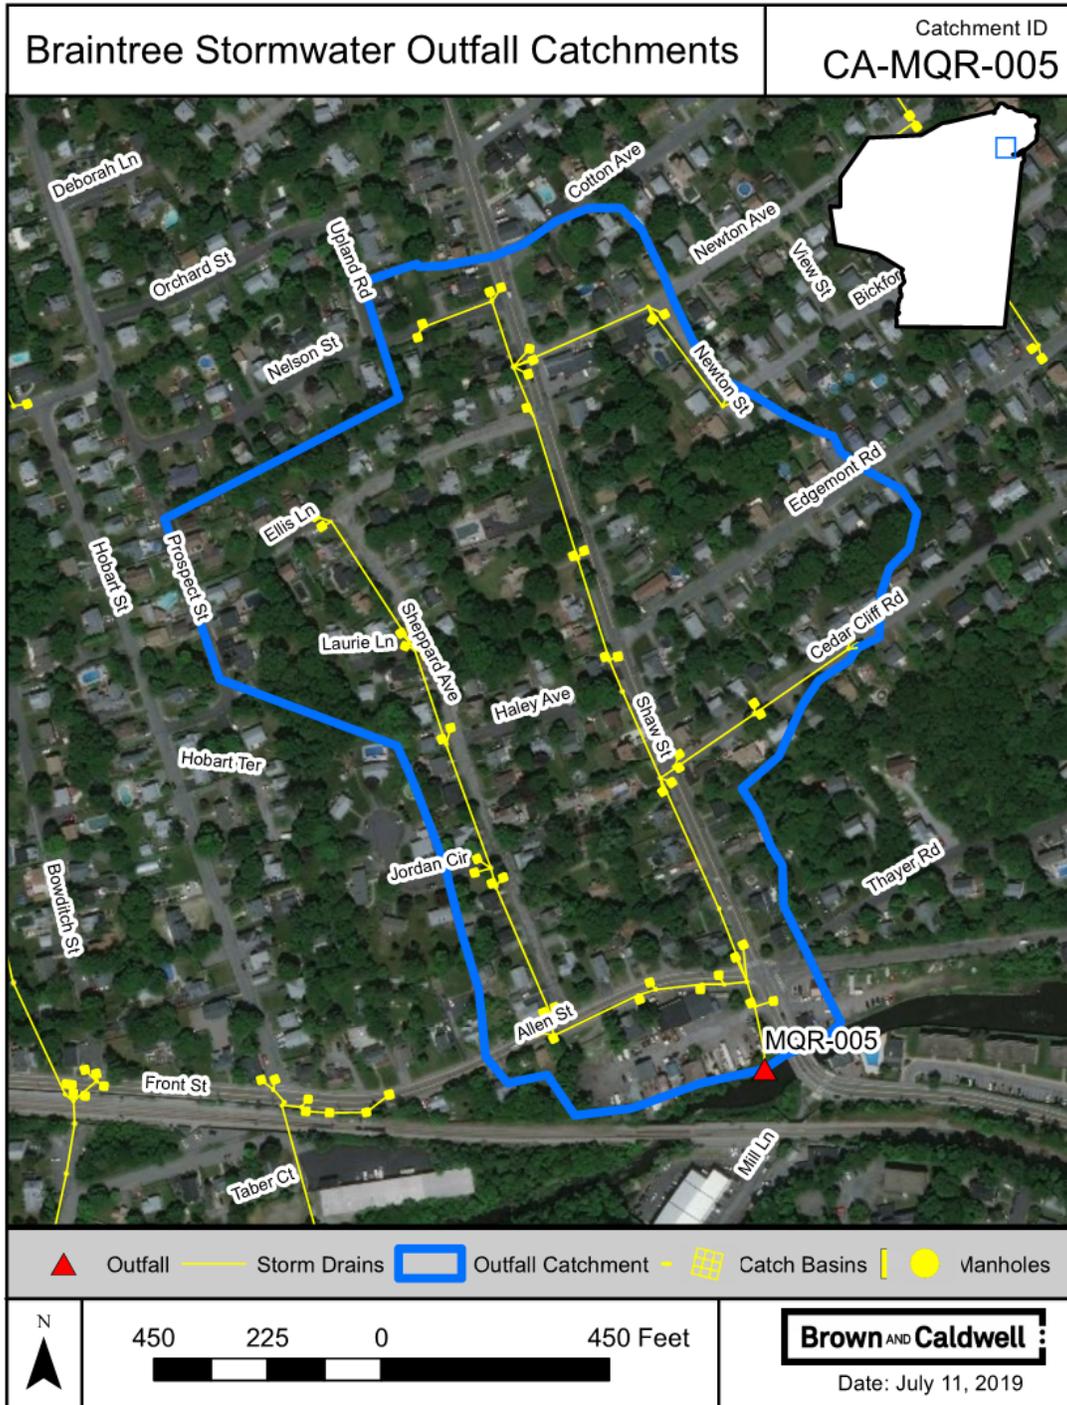
Figure 1. MQR-005 Tributary Area

The first outfall inspected was MQR-005. It is located on the North Bank of the Monatiquoit River near the intersection of Shaw Street and Allen Street. The outfall does not have a headwall. It consists of a steel pipe that sticks out into the river near the bridge on Shaw Street. This outfall is visible from the bridge and is suspected of being influenced by tidal waters only during astronomically high tides. The invert elevation of the pipe is just below the elevation of the underside of the bridge. Figure 1 provides a map of the MQR-005 drainage area. Figure 2 provides a photograph of the outfall on the day of inspection.

The results of the investigations at the outfall are shown in Table 2. Flows were observed at the outfall. There was no visual or olfactory evidence of sewage contamination and the bacteria concentration was 44 colonies/100 mL, well below the threshold. This outfall is not suspected having sewage contamination during the time of inspection.

Since the surfactant concentration of 0.25 mg/L was at the threshold level, upstream investigations were performed, but no sources of contamination were identified. This is to be expected since the bacteria data provides confirmation of no sewage contamination.

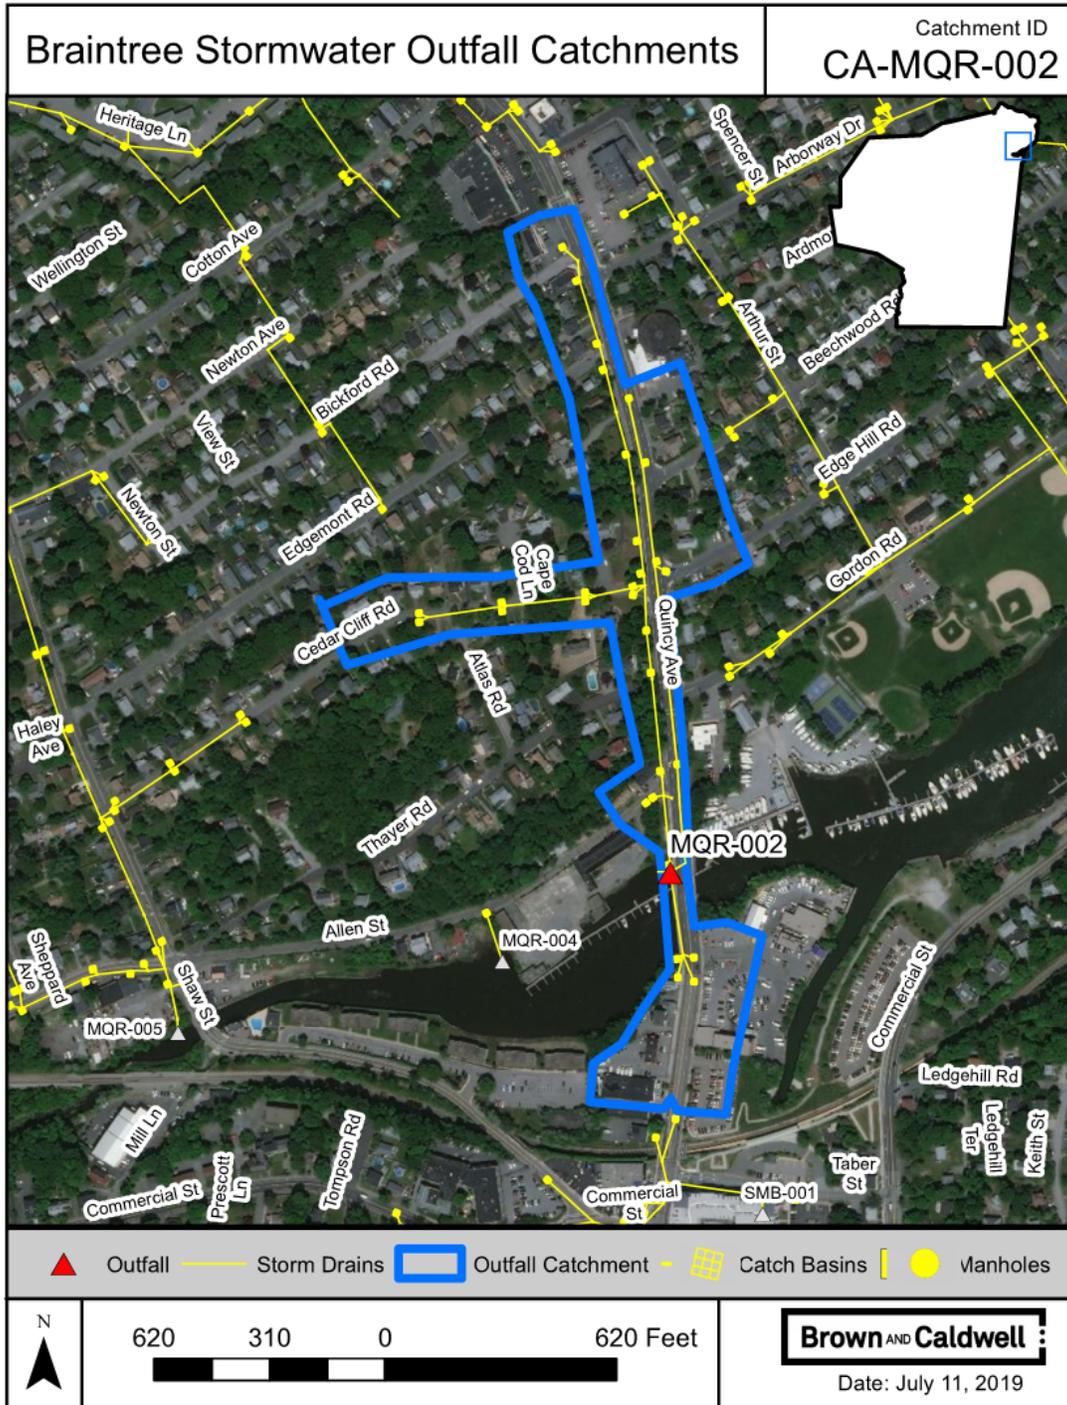
Figure 3. MQR-002 Tributary Area

The second outfall inspected was MQR-002. It is located on the North Bank of the Monatiquoit River in the bridge abutment of Quincy Avenue (Route 53). The outfall is located in the side of the bridge and flows down into a small pool that drains into the Monatiquoit River. This outfall is visible from the bridge and is suspected to only being influenced by tidal waters during astronomically high tides. The invert elevation of the pipe is just below the elevation of the underside of the bridge. Figure 3 provides a map of the tributary area to the outfall. Figure 4 provides a photograph of the outfall on the day of the inspection.

Flows were observed at the outfall. The results of the investigations at the outfall are shown in Table 2. There was no visual or olfactory evidence of sewage contamination and the bacteria concentration was 2 colonies/100 mL, well below the threshold. This outfall is not suspected having sewage contamination during the time of inspection.

Since the surfactant concentration of 0.25 mg/L was at the threshold level, upstream investigations were performed, but no sources of contamination were identified. This is to be expected since the bacteria data provides confirmation of no sewage contamination.

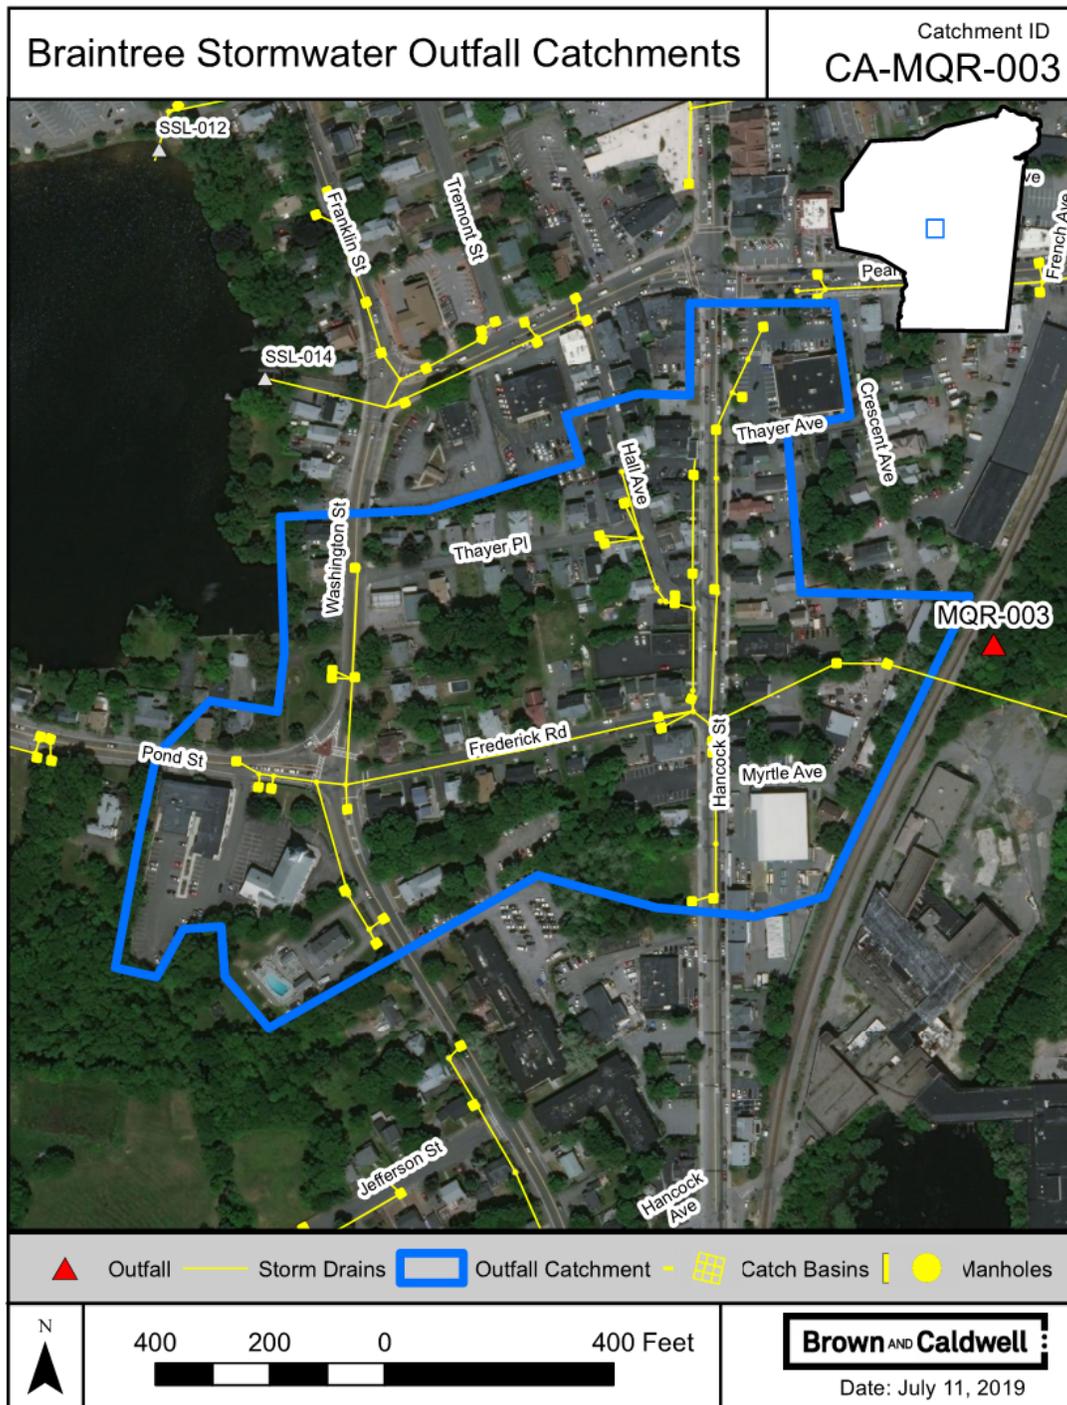
Figure 5. MQR-003 Tributary Area

The third outfall inspected was MQR-003. It is located on back side of the former industrial site that abuts Ames Pond and is in-between two active MBTA rail lines. The outfall is a stone square culvert that passes under the northern MBTA tail line and discharges to the Monatiquoit River downstream of Ames Pond. The outfall is in a remote area and access is via a steeply graded hill side. This outfall is only visible from the

heavily wooded area behind the Ames Pond property. Figure 5 provides a map of the tributary area. Figure 6 provides a photograph of the outfall at the time of the inspection.

The results of the investigations at the outfall are shown in Table 2. At the outfall, the discharge waters were opaque and cloudy. There was a slight odor of raw sewage as well. These characteristics are possible indicators of sewage contamination. The bacteria concentration was 4,000 colonies/100 mL. This

concentration exceeds the threshold. The ammonia and surfactant concentrations also exceeded the thresholds, with an ammonia concentration of 0.6 mg/L being well above the threshold of 0.25 mg/L. These results indicate that MQR-003 may have illicit contamination.

Source tracking was performed upstream of MQR-003. During previous inspections (see Technical Memorandum 1, Brown and Caldwell, September 24, 2019), this outfall was suspected of having sewage contamination from a privately-owned surcharging sanitary manhole on Crescent Avenue, just upstream from the outfall. The Town had previously contacted the property owner to resolve the contamination. Those efforts appear to be successful as the inspection found no signs of sewage contamination from the sanitary manhole to the storm drain catch basin.

Source tracking found stormwater flow in the manhole in the intersection of Hancock Street and Frederick Road. In addition to the field test kit measurements, bacteria samples were collected at this manhole. A sample was collected from the pipe inlet to the north (storm drain Hancock Street) and from the west (Frederick Road). The Hancock Street pipe E. Coli concentration was 3.0 colonies/100 mL, and the Frederick Road pipe E. Coli concentration was 23 colonies/100 mL. Both of these concentrations are well below the concentration of 4,000 colonies/100 mL measured at the outfall. This indicates that the illicit source is located somewhere between the manhole at Hancock Street/Frederick Road and the stormwater outfall.

outfalls at six-month intervals. If evidence of sewage contamination is identified, perform upstream flow tracking to isolate the source. If evidence of sewage contamination is not found on three consecutive investigations, change the status of the outfall to 'medium priority' and reduce the sampling frequency accordingly.

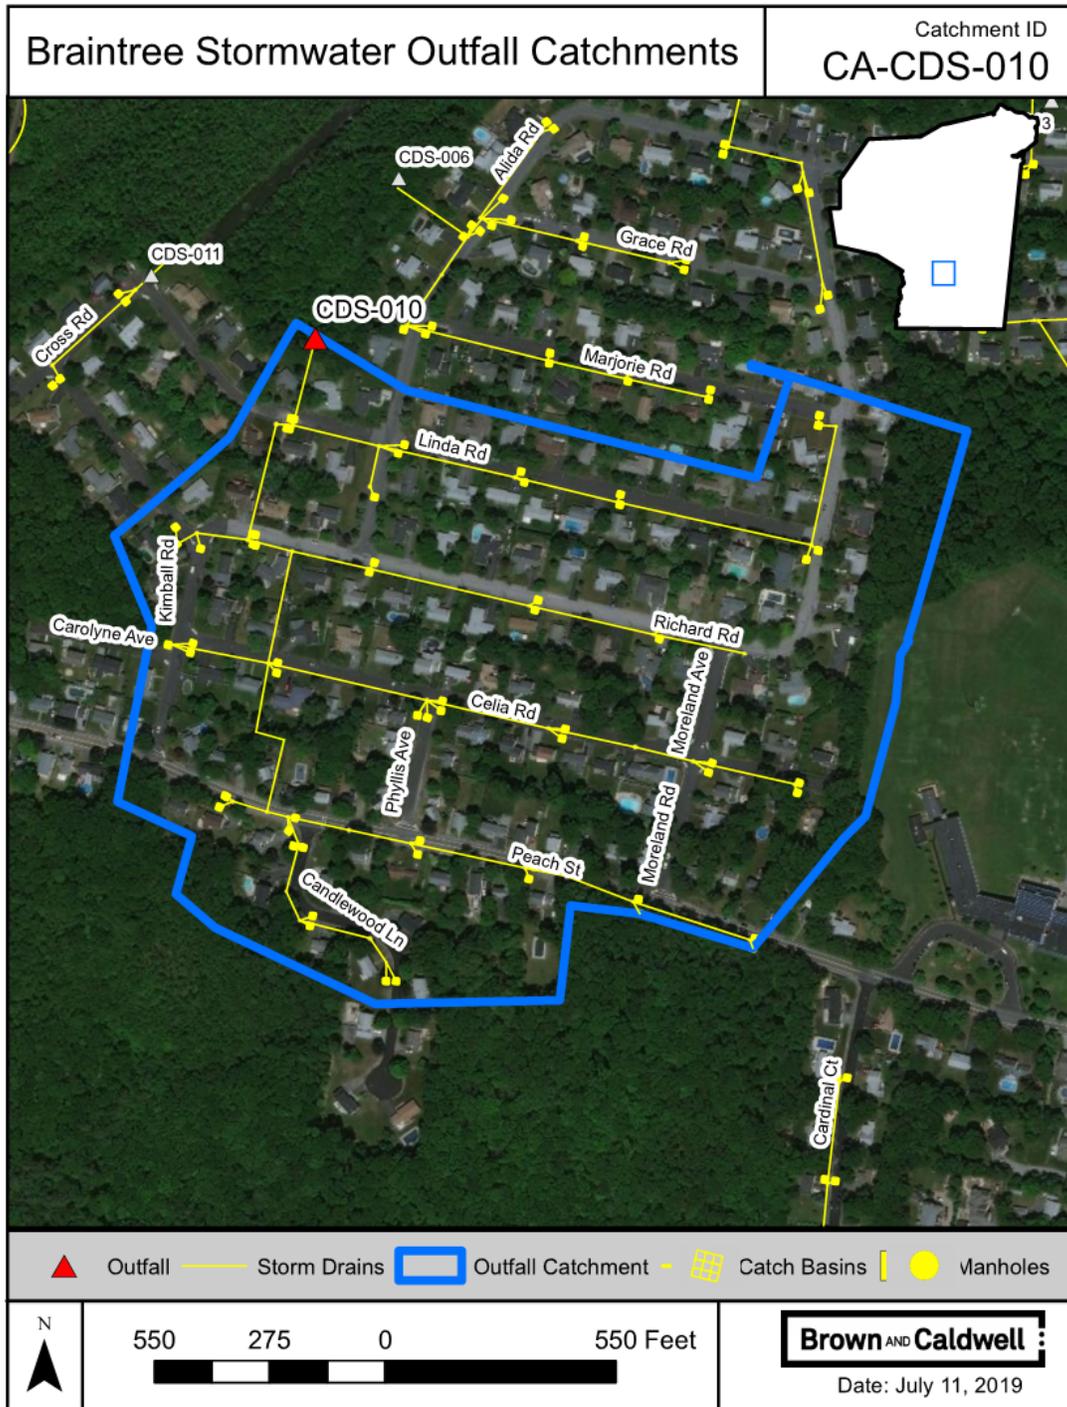
Figure 7. CDS-010 Tributary Area

The fourth and final outfall inspected was CDS-010. It is located behind the house number at 32 Linda Road. The outfall is accessed via a right-of-way adjacent to the house at 30 Alida Road. The outfall is partially submerged and has significant sediment deposits in the scour pool. The outfall discharges to a low-lying wetland area behind the residences. This outfall is only visible from the heavily wooded area behind Linda Road and Alida Road. Figure 7 provides a map of the outfall's tributary area. Figure 8 provides a photograph of the outfall at the time of inspection.

Since CDS-010 was submerged, the water quality sampling was performed at an upstream manhole. The results of the investigations are shown in Table 2. There was no visual or olfactory evidence of sewage contamination. The bacteria concentration was 8.6 colonies/100 mL, below the threshold. Field test kits were not performed at this outfall because discoloration of the water made it difficult to interpret the field test kit results. CDS-010 is not suspected of having sewage contamination at the time the inspection was performed.

Even though the field test kits could not be performed at the manhole upstream of the outfall, upstream source tracking was initiated based on past evidence of sewage contamination at this outfall. Fortunately, the team was able to perform the field test kits at the upstream manholes which were unimpacted by the discoloration issues near the outfall. No conclusive evidence of sewage contamination was observed during the upstream source tracking which is consistent with the low bacteria concentration measured upstream of the outfall.
